Manhole Inspection Summary

Manhole # S69W__009MH

Location Address: **6601 Chandlery St.**

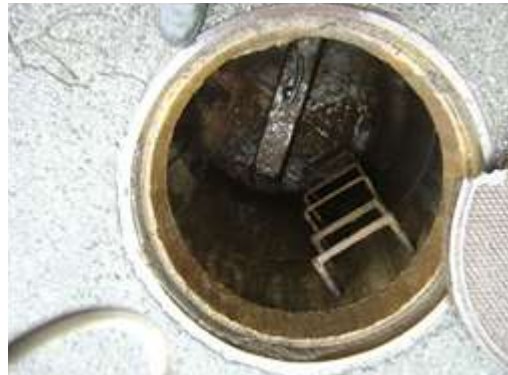
Top View

Comments **MANHOLE COVER BROKEN AND THE MISSING PIECE IS IN THE CHANNEL.**

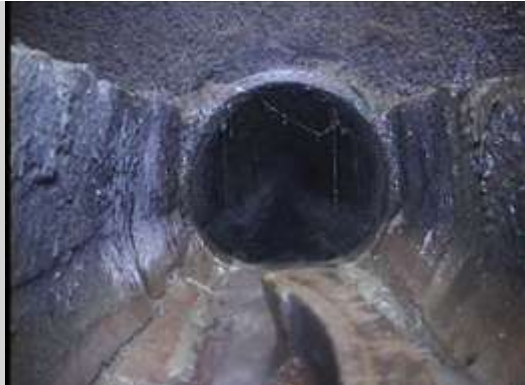
12 O'Clock Outflow

8 in. Circular Gravity Sewer
Pipe Out @ 12 O'Clock

Pipe Height: **8.4** (in.) Rod and Bar (Angled)
Pipe Material: **Clay** ☐ Pipe Lined
Invert Depth: **7.67** (ft.) Flow Characteristics: **Fast**
Deposits: ☒ None ☐ Mud ☐ Sludge ☐ Debris ☐ Grease
Silt Depth: (in.) Deposits Extent:
Infiltration: **None** Pipe Seal Cond: **Sound**
